Technical Service Bulletin

Number TSB-TM1-1

Date: 7/27/25

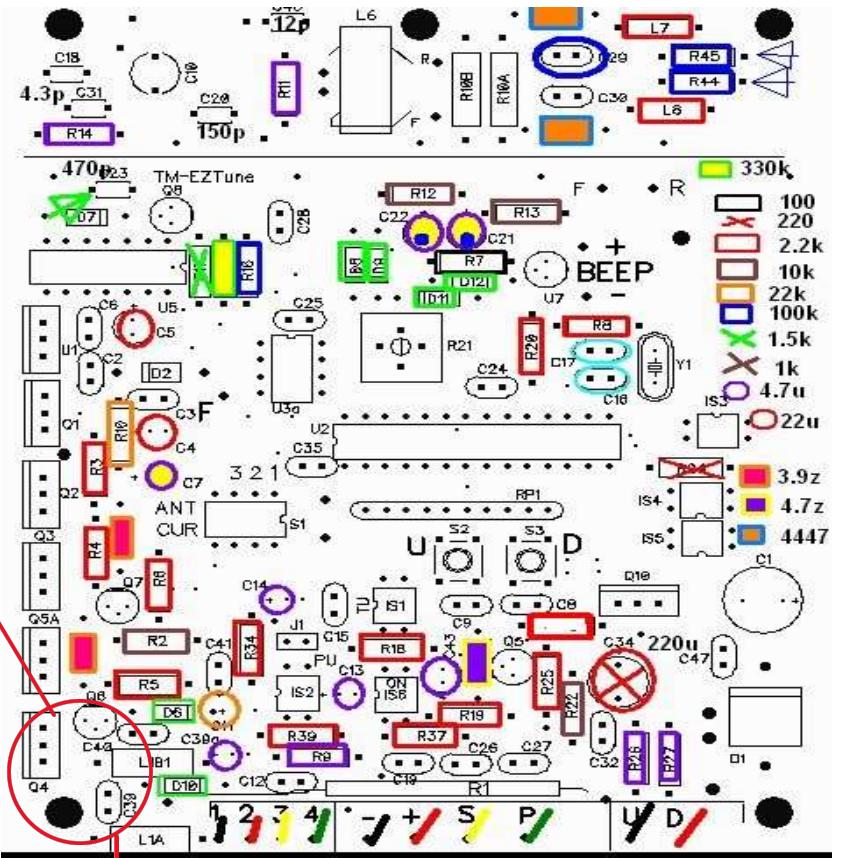
TM1/TM EZTune:

To eliminate the possibility of the output driver oscillating. This issue may or may not occur, but it is recommended to perform the service to eliminate any potential effects. This oscillation can cause overheating of the output driver MOSFETS in affected products, which can damage the parts, including burned components and failures causing the main power fuse to blow. Once damaged, the MOSFETS would need to be replaced. This bulletin eliminates this potential issue.

- 1) Remove rear panel by removing four(4) #6-32 flathead screws from rear of unit.
- 2) Locate C39 & C40 (located near the output chokes), and remove with cutters or pliers, completely removing all debris, and making sure no leads remain.
- 3) Re-attach rear panel.
